## **MICROBIOLOGICAL CORROSION**

## MICROBIAL CORROSION TYPES

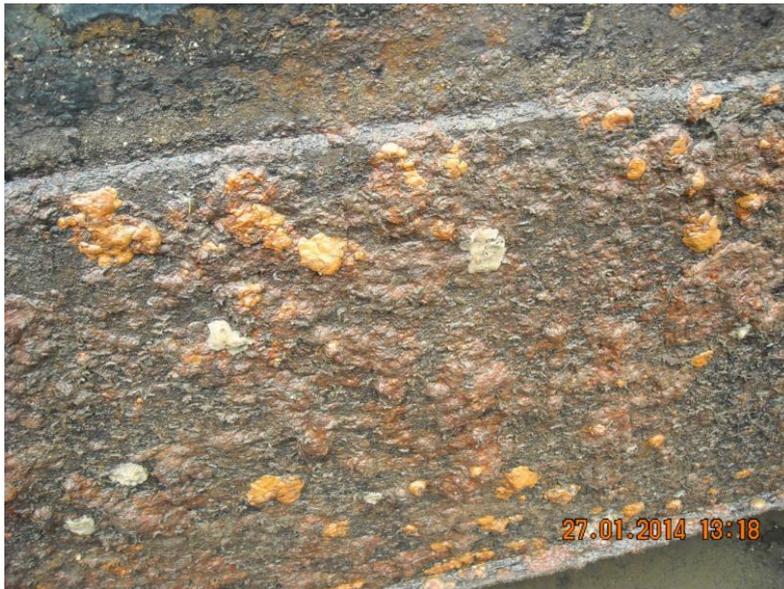
### 1. *GALLIONELLA FERRUGINEA*

Characteristically leaves a fairly shallow pit of approximately oval shape and a 'rusticle' made of ferrous and ferric hydroxide. This is a brown non-toxic insoluble powder with black streaks. It is not rust though a marine surveyor has described it in one of his reports by the curiously contradictory name of 'living rust'. The name 'rusticle' was given to the detritus by Dr. Ballard when he found extensive amounts of the stuff on the wreck of the Titanic. It is commonly found on narrow boats and other canal barges in the form of an orange bloom or paste-like phenomenon, often in rings around deeper pits formed by the *thiobacillus ferro-oxidans* corrosion (see (2) below). Being easily washed off, the orange corrosion is frequently considered to have been eradicated. Not so.

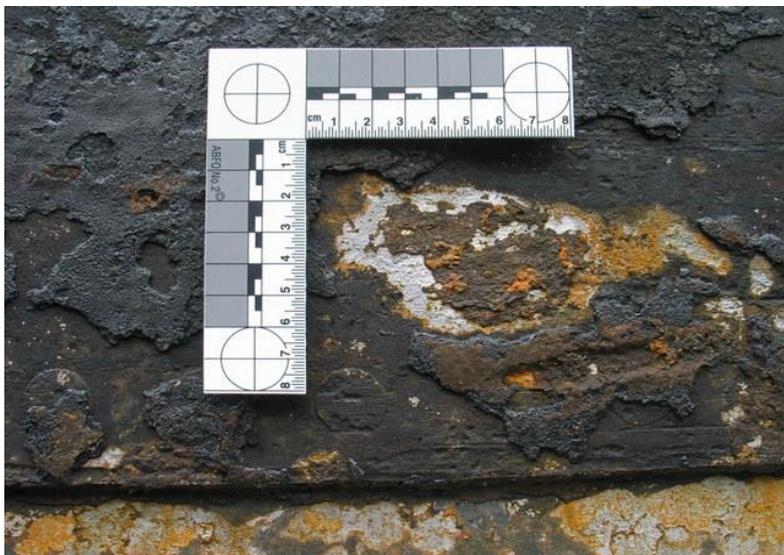
### 2. *THIOBASCILLUS FERRO-OXIDANS*

Often closely associated with the *gallionella* species, *thiobacillus ferro-oxidans* is a sulphur oxidizing bug (SOB). This leaves a similar pit to the *gallionella* species but with vertical stepped sides and the flat bottom covered with a hard silver-white substance. The latter is tetra hydrated ferrous sulphide and is non-toxic. It appears not to rust but will eventually start to discolour.

\*The white deposits are the tetra-hydrated ferrous sulphate also known in its mineral form as rozenite [FeSO<sub>4</sub>·4(H<sub>2</sub>O)]. Note also the high surface area/depth ratio of the pitting. There can also be signs (small red-brown rusticles) of attack by microbes of the symbiotic species *Gallionella Ferruginea*. The presence of the sulphate prevents the steel underneath from rusting (oxidising) but NOT from corroding. (The vessel photographed above was constructed of Siemens-Martin mild steel).
